**Directorate of Aircraft Accident and Incident
Investigations**

Accident Reference: ACCID/083022/01-03

**Aircraft Accident Investigation Preliminary
Report**

DESCRIPTION OF OCCURRENCE: Cessna210N crashed into the river

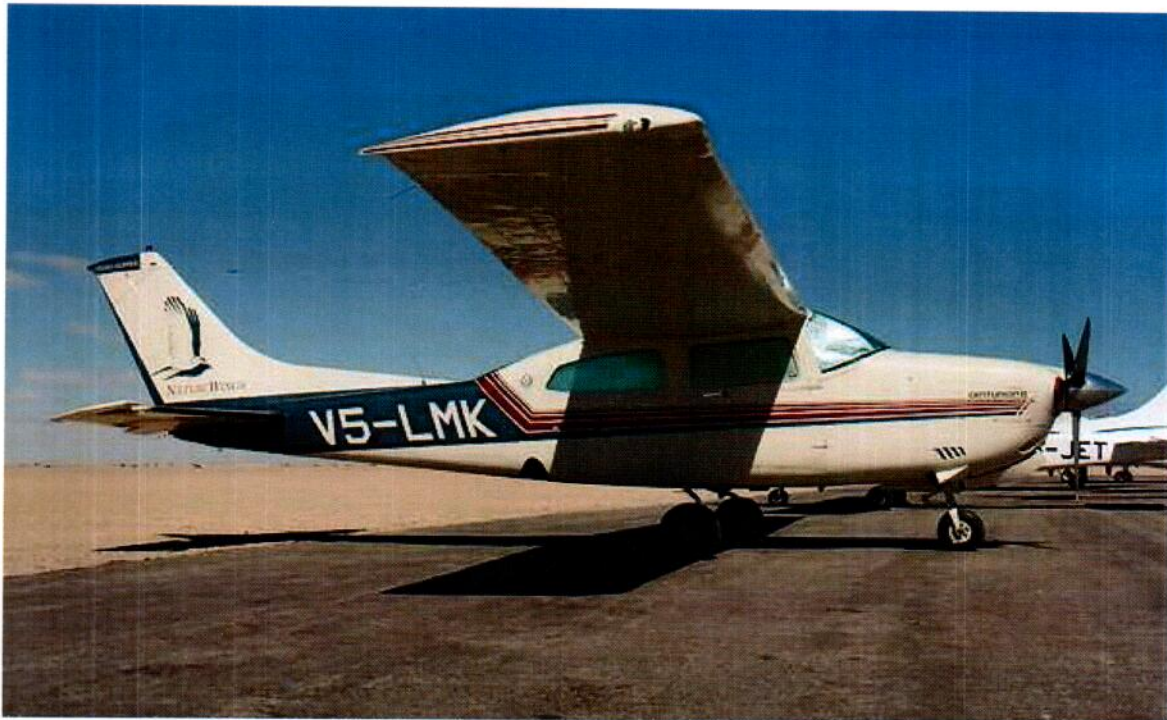
Figure 1: The Cessna 210N aircraft V5-LMK accident aircraft (source: Operator)

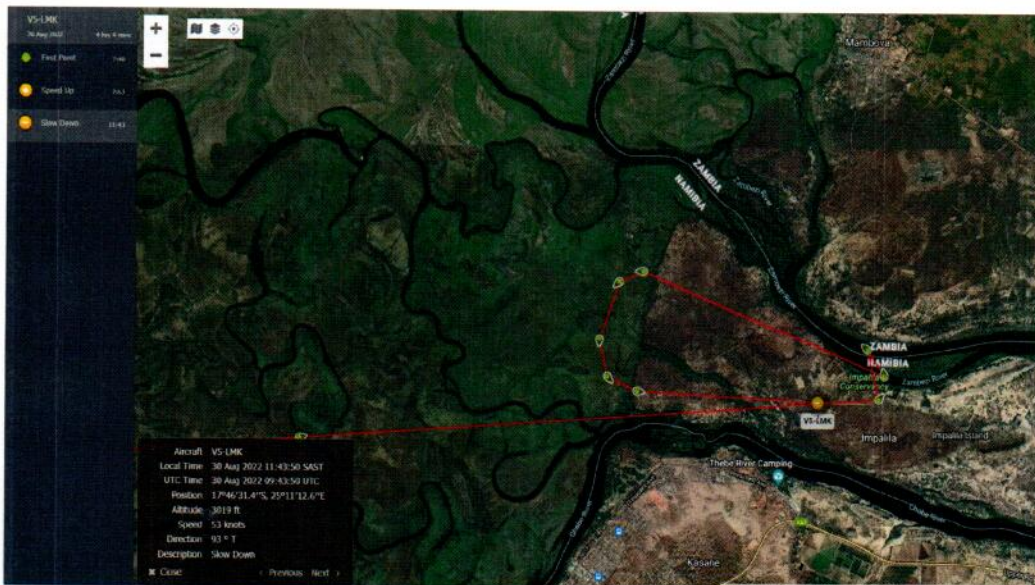
Figure 2: Picture showing the aircraft approach and landing at Impalila Island airstrip (sources: spider track fitted on the aircraft by Skycore)

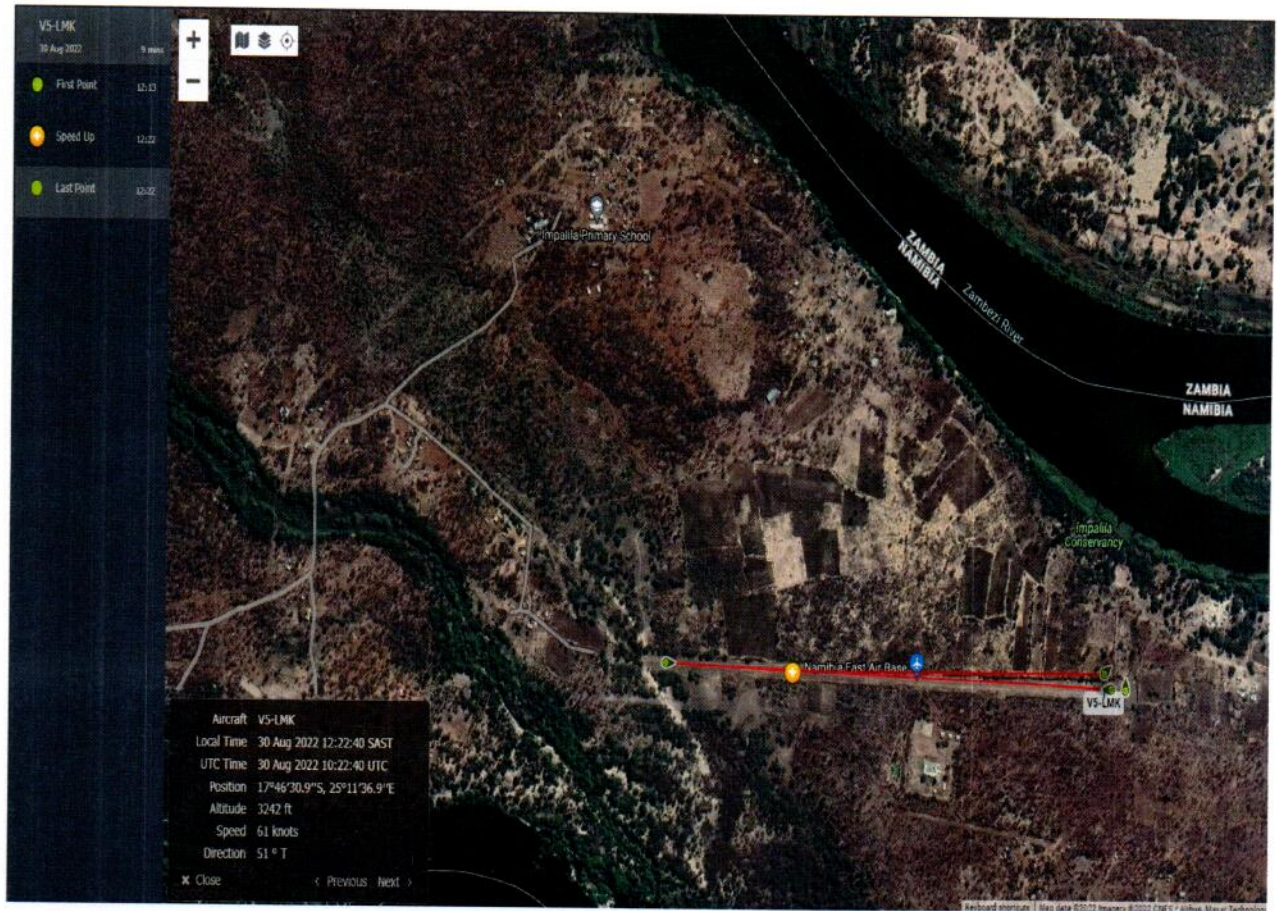
Figure 3: Picture showing the take-off from Impalila Island and the data pertaining to the take-off maneuver performed by the aircraft before it crashed.

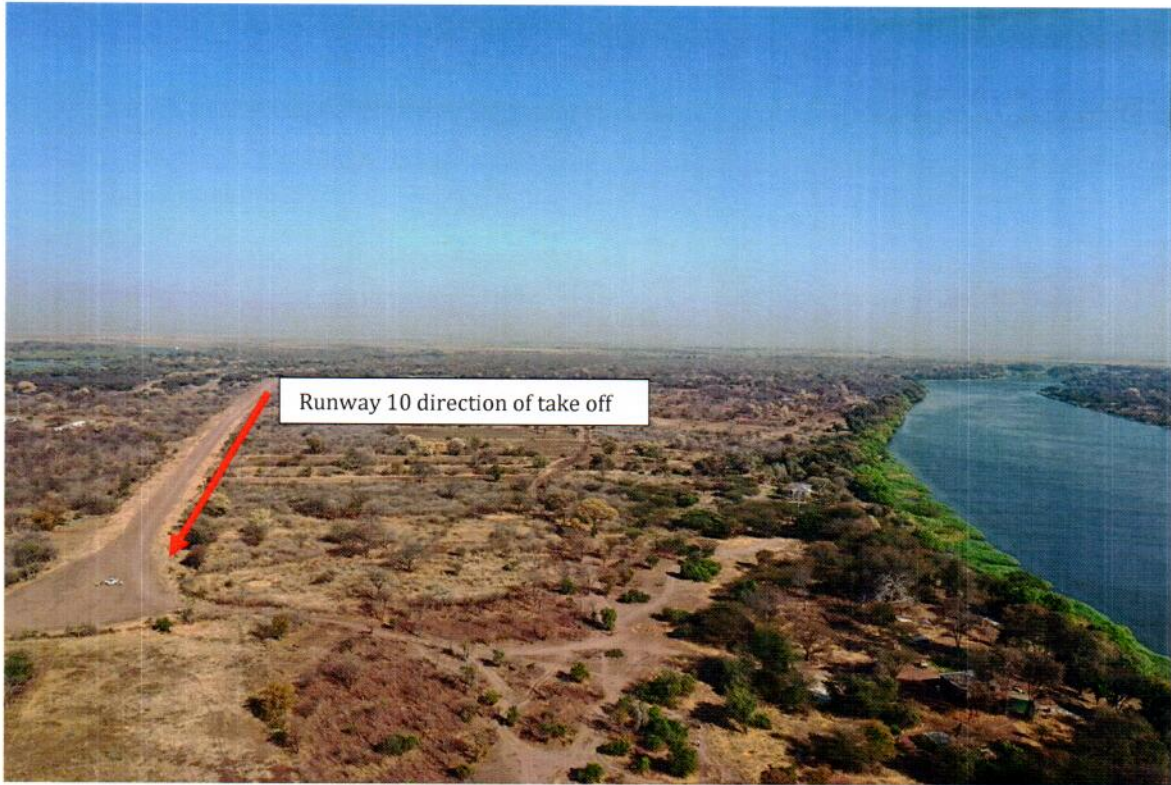
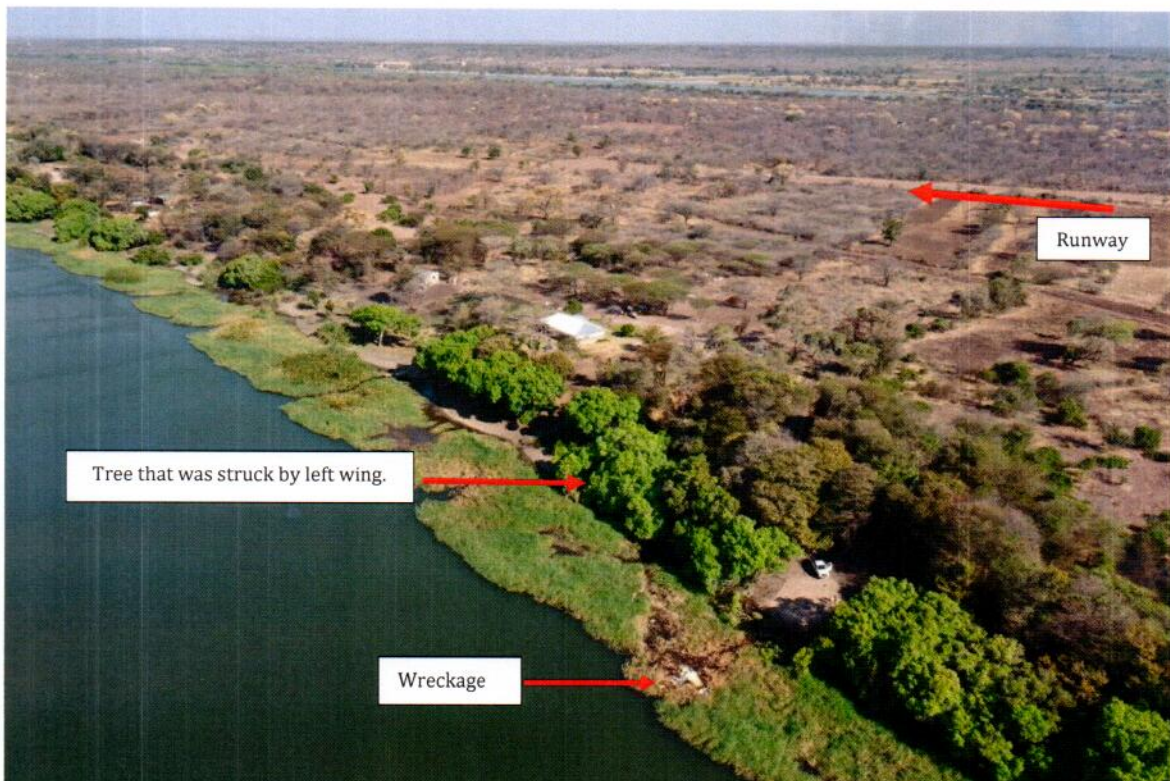
After take-off the aircraft made a left turn and crashed on the bank of Zambezi River.

Figure 2,3: Pictures showing the Direction of takeoff and where the aircraft crashed.

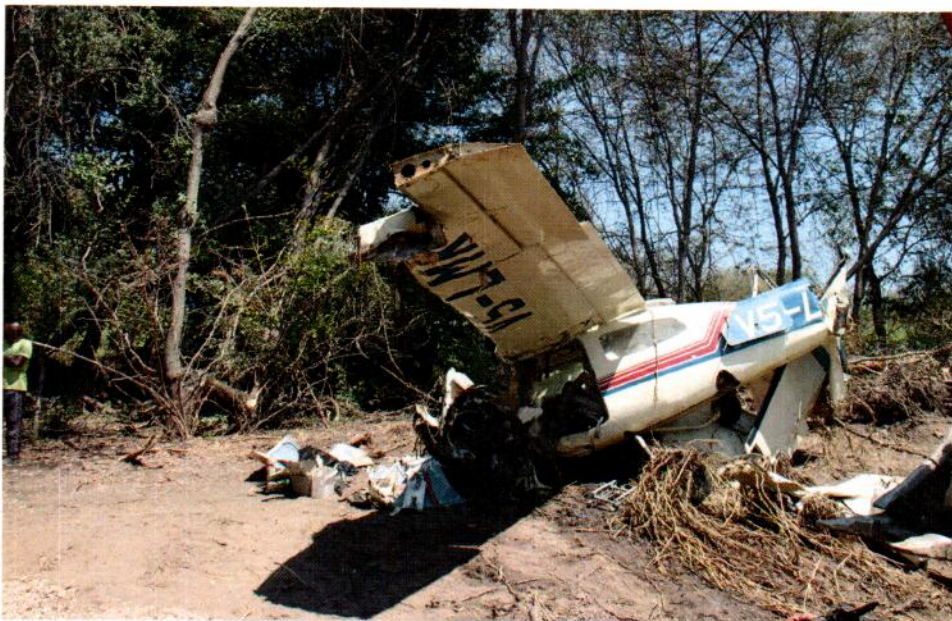
1.3.1 The aircraft was destroyed.

Figure 4: Picture showing how the aircraft was damaged (picture was taken after recovery)

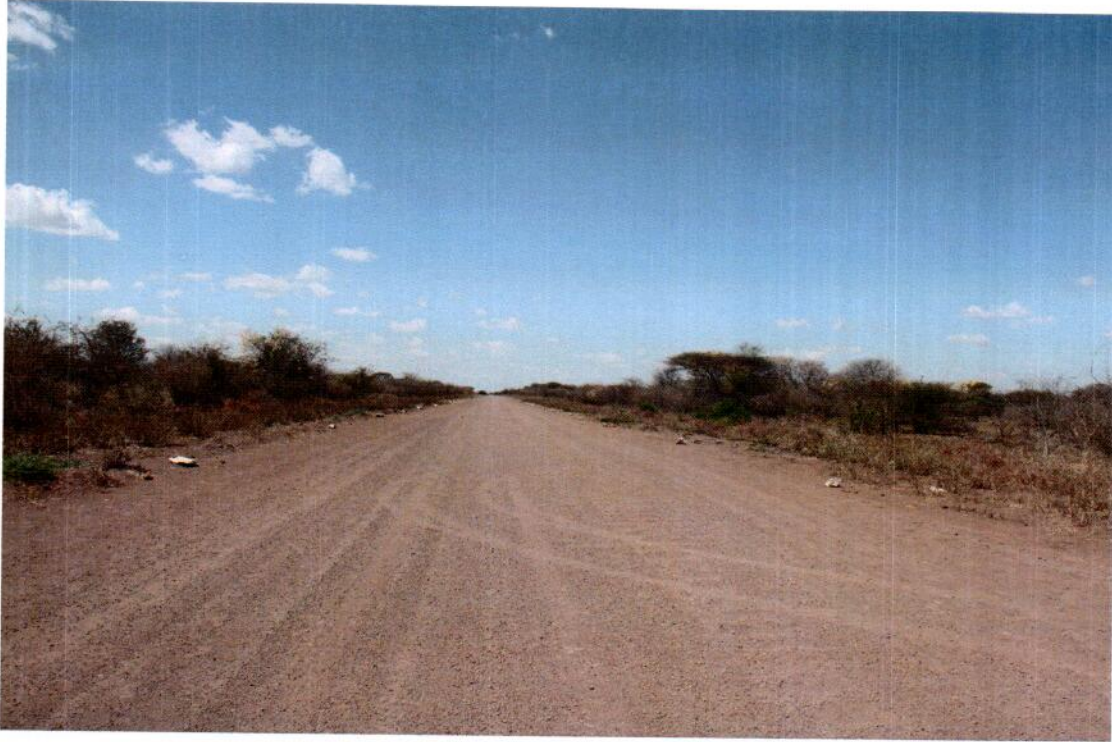
Figure 5: Picture showing the Impalila Island runway facing into the Easterly direction.

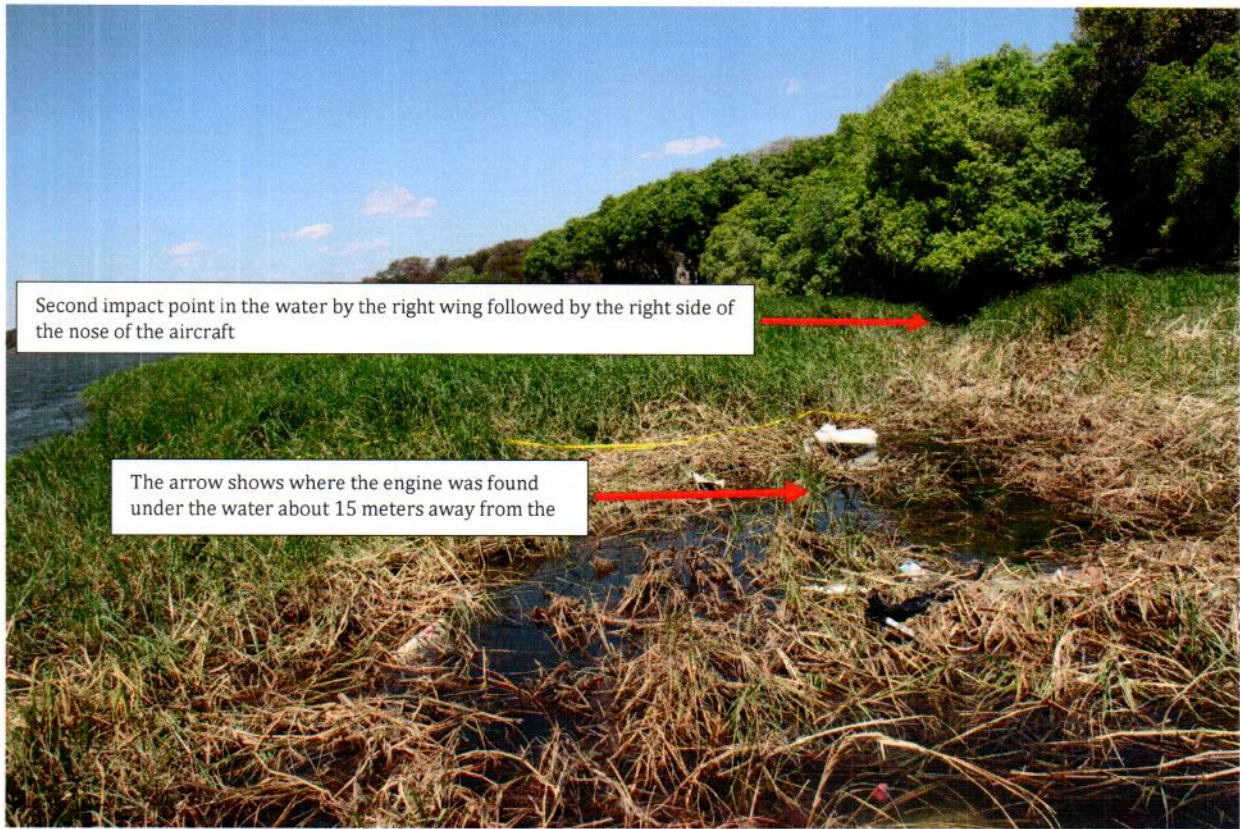
- 1.12.1 After take-off from runway 10, the aircraft made a left turn, thereafter the left wing struck the tree and it crashed a few seconds later into the bank of Zambezi River. The right-wing tip fuel tank was found at the beginning at the first point of impact. The engine was found under water in the impact trail, about 15 meters away from the main wreckage. The main wreckage was found around 40 meters away from the impact point facing into a southerly direction. The nose section was totally destroyed and the instrument panel was just attached to the fuselage by cables. The main aircraft fuselage was destroyed; the tail sections broke and bend towards the right side of the aircraft. The fuel and other oil and lubricants had leaked away into the river.

Figure 8: Picture showing the impact sequence in the water

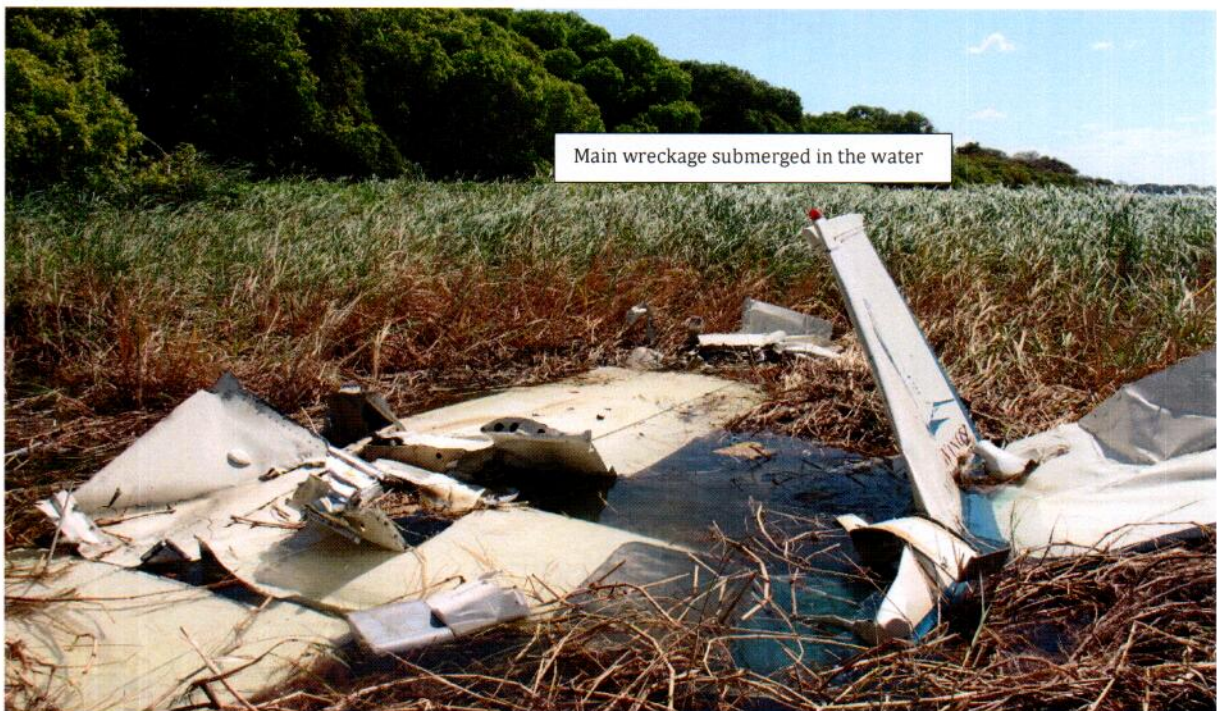
Figure 9: Picture showing the aircraft wreckage as it was found in the water.

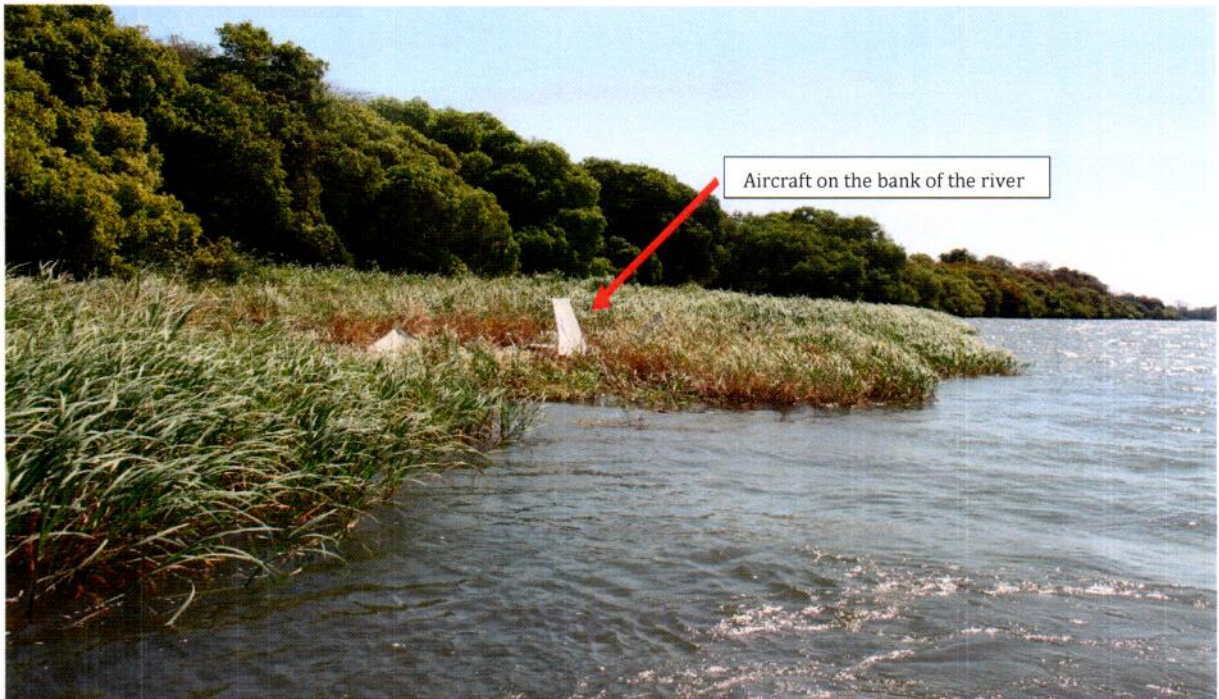
Figure 10: Picture showing where the aircraft ended up on the river bank

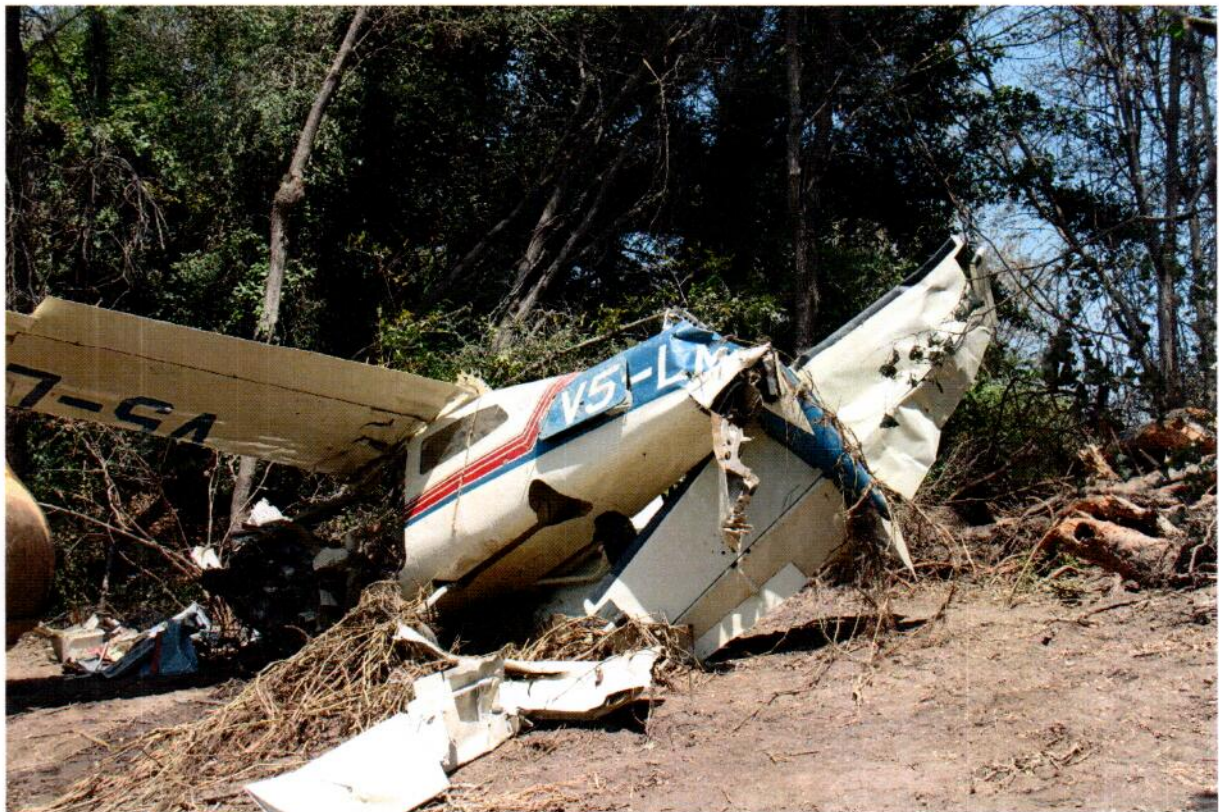
Figure 11: Picture showing extend of damage to the aircraft.
