**REPUBLIC OF NAMIBIA  
MINISTRY OF WORKS AND TRANSPORT**

**Accident Reference: ACCID/05102026-05-01**

**Cessna 210: V5-KER**

**Aircraft Accident Investigation Preliminary  
Report**

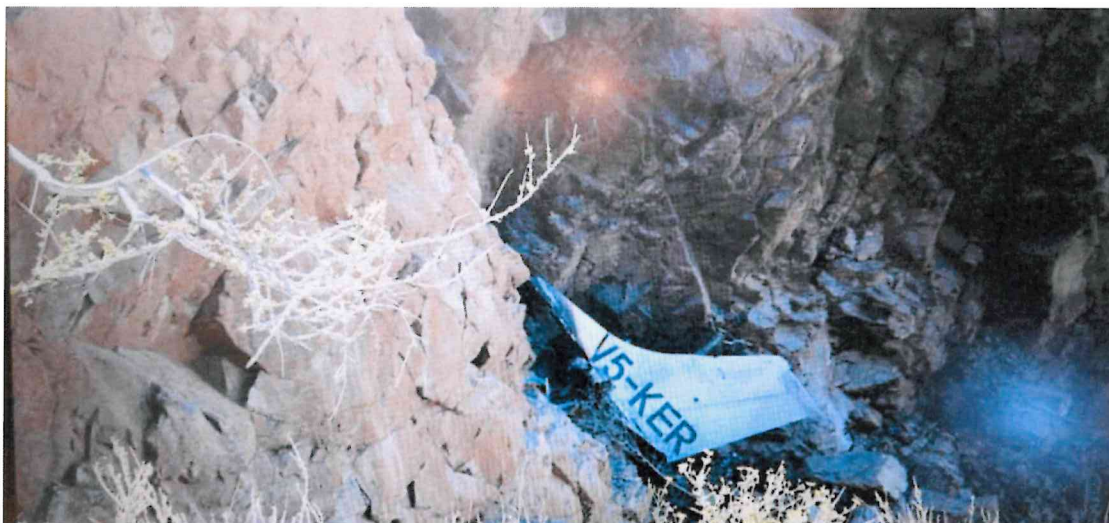
- 1.1.9 The wreckage of the aircraft was consumed by post-crash fire and all 4 occupants on board the aircraft were fatally injured.

Figure 3: Photo taken when the wreckage was discovered confirming the registration mark as that of V5-KER.

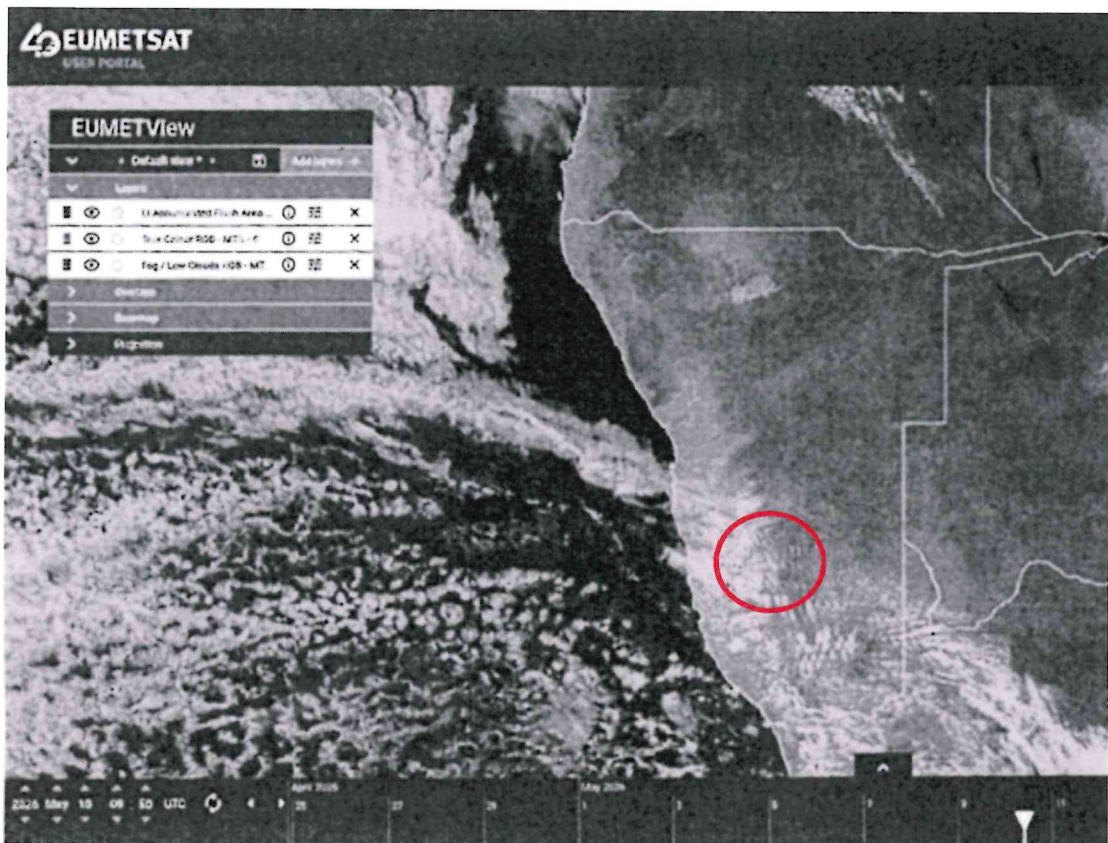
Figure 4: Satellite image shows cloud cover where the accident occurred (red circle). Date: 10 May 2026  
Time: 09:50 UTC.

- 1.7.2 People staying and working at Hammerstein, reported that the area was covered in low clouds and that the clouds only cleared up at around 14:00 local time (12:00 UTC).
- 1.7.3 Pilots that were flying in the area also reported low clouds and reported that the mountains were covered by low clouds.
- 1.7.4 More information about the weather will be shared in the final report.

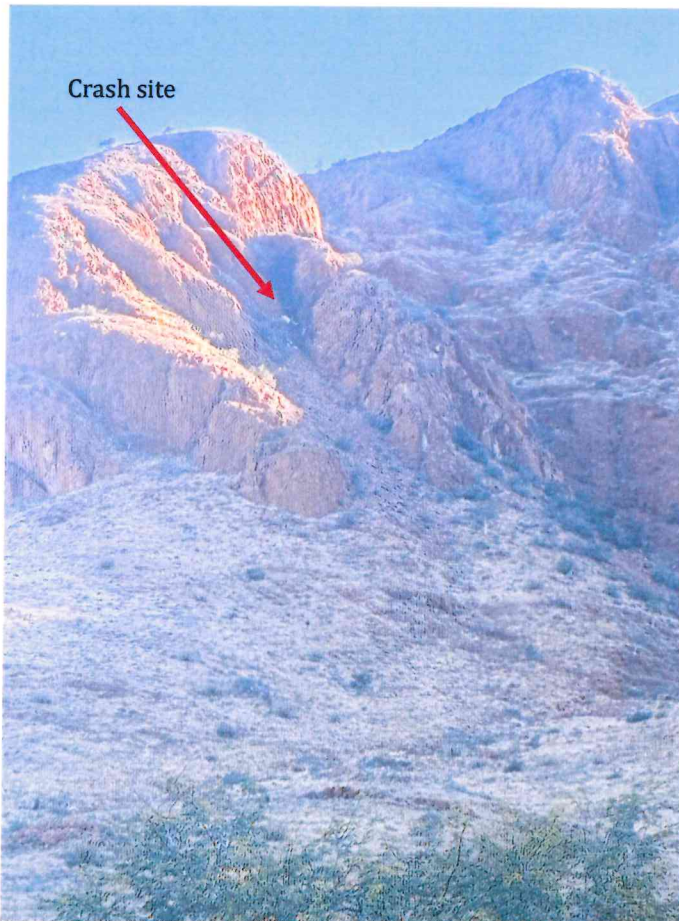
- 1.12.1 The Aircraft collided approximately 3 quarters up the mountain in a sheer section of the cliffs. The right wing and its detached wing tip were the first components in the wreckage trail. The aircraft came to rest in the rock crevice and burst into flames. The propeller and hub detached from the aircraft and was lying a few meters from the main wreckage.

*Figure 5: Picture showing the location of the crash site.*

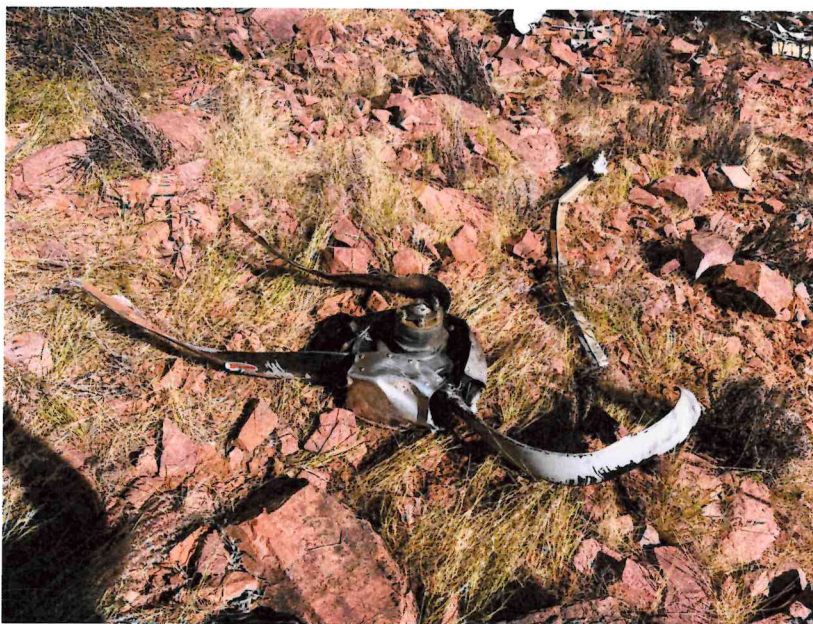
*Figure 6: Picture showing the propeller and hub.*

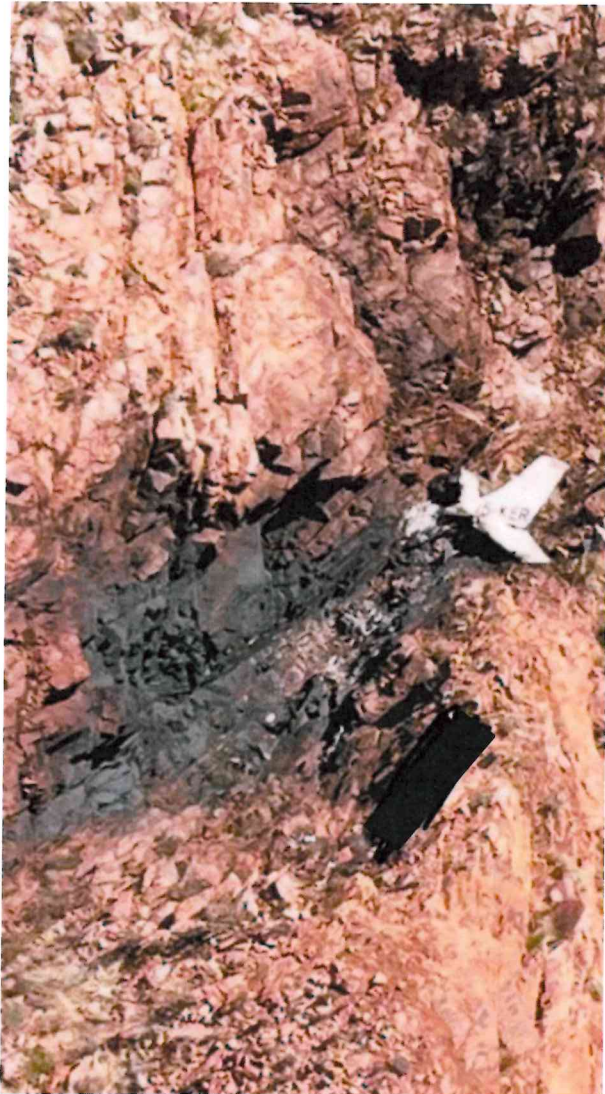
*Figure 7: Main wreckage, consumed by post crash fire*

1.14.1 The aircraft was consumed by post-crash fire.
